HD-Stabilizer links

MEYLE-HD

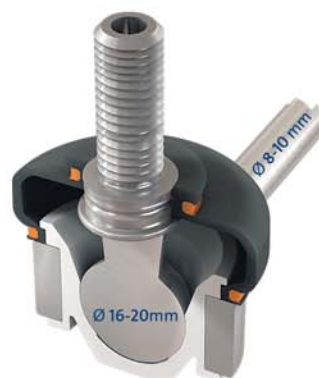
as OE

Intense strain causes wear and stress of the components

Premature failure of the ball joint
Noise from the front axle

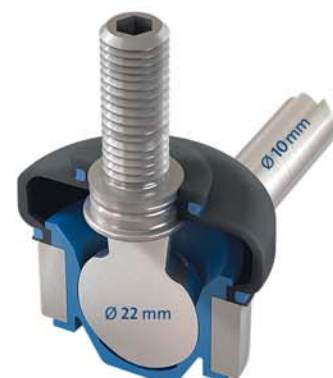
MEYLE version

- Enlarged ball diameter (22mm)
- Reinforced link rod
- MEYLE high-tech grease
- Wear resistant blue plastic seat

Significantly longer service life thanks to reinforced design
