**MEYLE**<sup>®</sup>  
Products

## Control arm to fit Mercedes Sprinter, VW LT II

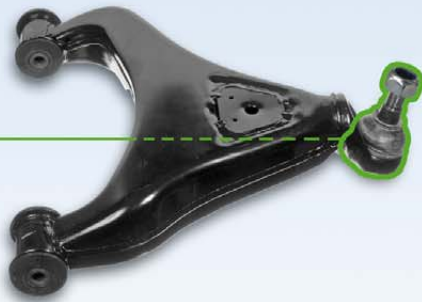
Intense strain of the control arm due to overloading of the vehicle and fast driving

- Worn out ball joints
- Damaged rubber mounts
- Noise from the front axle

- Exchangeable ball joints with improved quality
- Wear-resistant plastic seats in the ball joint (developed in cooperation with **Lufthansa Technik Intercoat GmbH**)
- MEYLE high-tech grease
- Delivery incl. nut
- Exchangeable rubber mounts
