MEYLE[®]
Products

MEYLE No. 300 311 2909/HD
Reference No. 31 12 0 006 482
31 12 1 093 707

Control arm bushings to fit BMW E38, E39

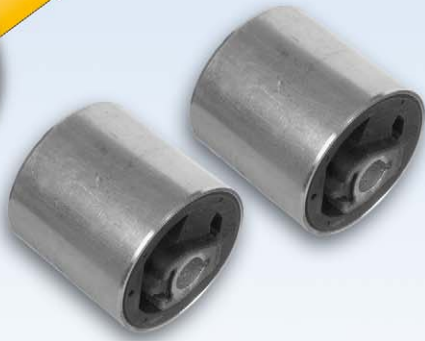
Problem

Solution
<p>High dynamic strain causes leakage of the hydro-liquid.</p>	<p>Replacing the hydro mount with a full rubber mount</p>
<p>Effect</p>	<p>Advantage</p>
<ul style="list-style-type: none"> • Vibration in the steering • Reduced driving comfort 	<p>No leakage possible and significant longer lifetime with more driving comfort</p>
