MEYLE No.	Reference No.
Bushing	014 033 0024/HD	140 333 18 14 26
Repair kit	014 033 0015/HD	140 330 82 07

Bushing, control arm to fit Mercedes W140, C140

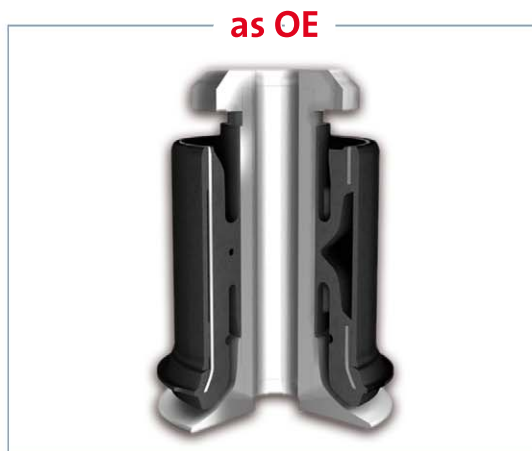
Problem

<p>Leakage of hydro fluid due to high dynamic strain and small bonding surface</p>	<p>Hydro mount replaced by an optimised full-rubber mount with a larger bonding surface</p>
Effect	Advantage
<ul style="list-style-type: none"> • Steering vibration • Impaired driving safety 	<ul style="list-style-type: none"> • Leakage no longer possible • Significantly longer service • More safety • More driving comfort
